MARINE INVESTIGATION REPORT

M99L0126

GROUNDING AND CONSTRUCTIVE TOTAL LOSS

THE BULK CARRIER *ALCOR*

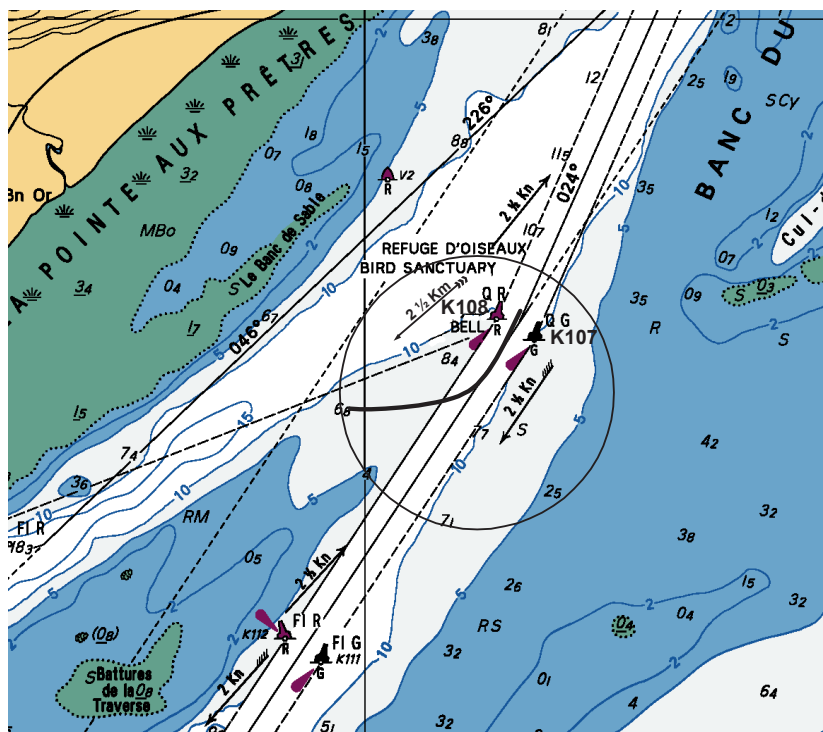
Figure 1. Approximate track of the Alcor from channel to grounding position

By this time (1440), the ship was veering out of the channel on a heading of approximately 265° T. The master had already re-entered the wheelhouse interior and was assisting the navigation team. The chief officer had come to the wheelhouse and quickly deployed to the forecandle to standby the anchor. Shortly afterward, the astern thrust became effective and the vessel slowed considerably. The pilot was informed at or about this time that the rudder was responding to helm action. By 1444, the vessel had effectively come to a stop.

Engine movements ahead were attempted in the hope of reaching deeper water, barely one cable ahead, but to no avail. The starboard anchor was then let go. The vessel was now aground, at position latitude 47°03' 29.5" N, longitude 070°45' 09.1" W, on a heading of approximately 285° T. (See Figure 1 for the vessel track as recorded by the pilot's portable differential global positioning system [DGPS].)

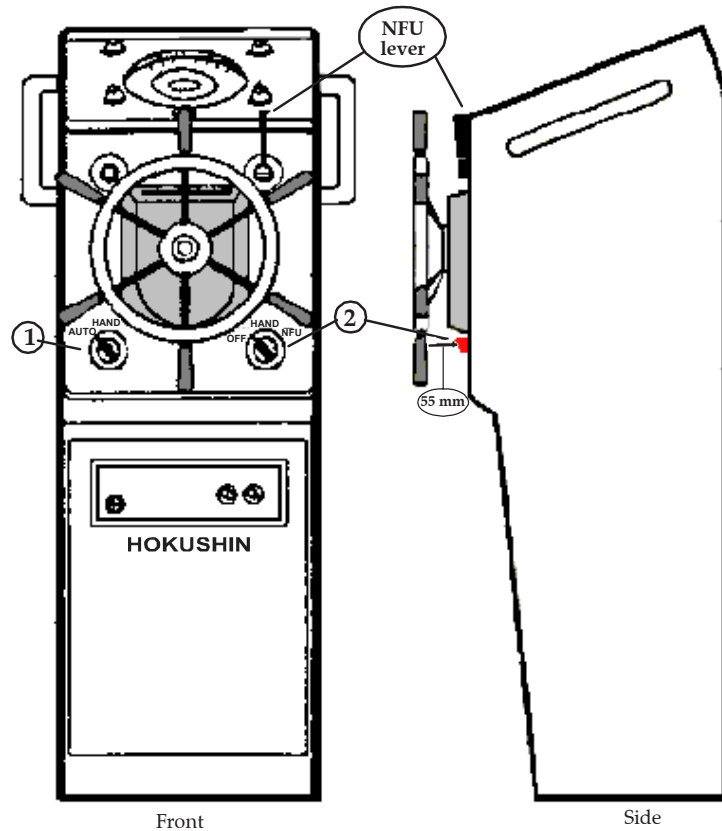
Figure 3. Helm unit of Hokushin steering control system

The *Alcor* was fitted with a Hokushin steering control system, model PT-7J2. This system, fitted during construction of the vessel and approved by the classification society, includes an all-electric helm unit, incorporating hand-steering capabilities and autopilot functions. One switch selects either autopilot or hand steering and is located on the lower left-hand side of the steering unit front piece (see Figure 3, front view, switch No. 1).¹⁰

If hand steering is selected on switch No. 1, a second, three-way SMS switch (No. 2), labelled "Pilot Main" on this unit, permits the choice of OFF, HAND, or NFU. Switch No. 2 is located on the lower right-hand side of the steering unit front piece, 55 mm behind the spokes of the steering wheel.

The detent torque required to turn the SMS switch was found to be 0.6 newton/metre (Nm).¹¹ No quantitative norm or regulation governing detent torque is known to exist for this type of switch in this type of application.

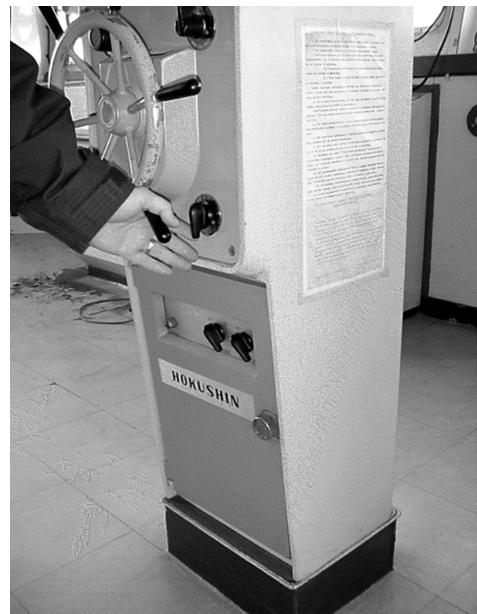
Photo 1. Simulation of accidental switch activation

The SMS switch of the helm unit is 55 mm behind the spokes of the hand steering wheel. Simulations conducted after the accident revealed that the switch could be accidentally thrown right, to the NFU position, when the wheel was turned to the right, or left, to the OFF position, when the wheel was turned to the left.²¹ With the low detent torque of 0.6 Nm, this switch was relatively easy to turn by simply leaving the fingers of the hand extended while turning the wheel (see Photograph 1). The location and orientation of this switch were such that accidental activation was possible. There was no protective barrier or alarm for this switch.

Many models of ship helm units incorporate safety features, such as alarms or guards on the SMS switch. These switches are also in a location and orientation that reduce accidental activation. Also, the detent torque on many models has been observed to be considerably higher than it was on the *Alcor*.

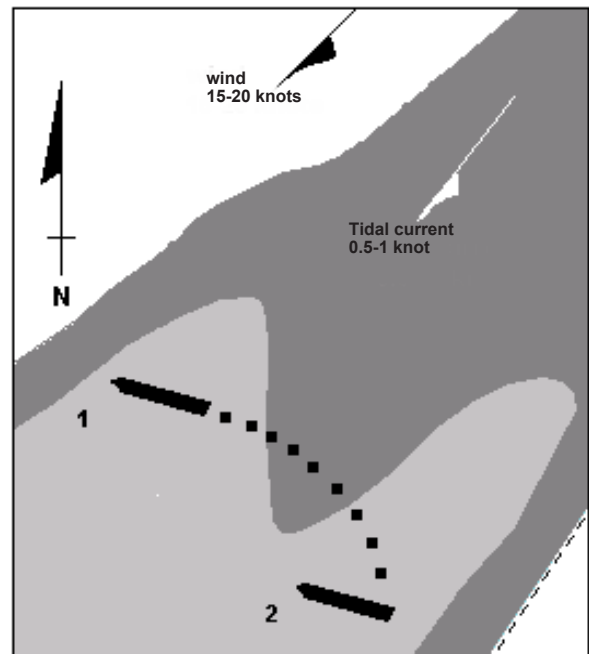
Figure 5. Initial (1) and second (2) grounding positions (all positions approximate)

Soon after the *Alcor* began to move astern, the tugs stopped assisting under the salvage master's instructions, while the engine of the *Alcor* was kept moving astern for approximately two minutes. During this time, the vessel's heading was fairly constant at about 285° T. Soon after the vessel started astern, the salvage master inquired of the pilot, who was at one of the radars, if the vessel was in safe water. When the pilot responded in the affirmative, the salvage master put the engine of the *Alcor* to stop; the salvage master had not yet handed the con over to the pilot. Shortly after this, the ship stopped moving astern. The engine was again put to full astern by the salvage master and the tugs resumed their assistance, but to no avail. The *Alcor* had moved some 2.8 cables to the southeast and had grounded for a second time at position 47°03'08" N, 070°45'12" W (see Figure 5).

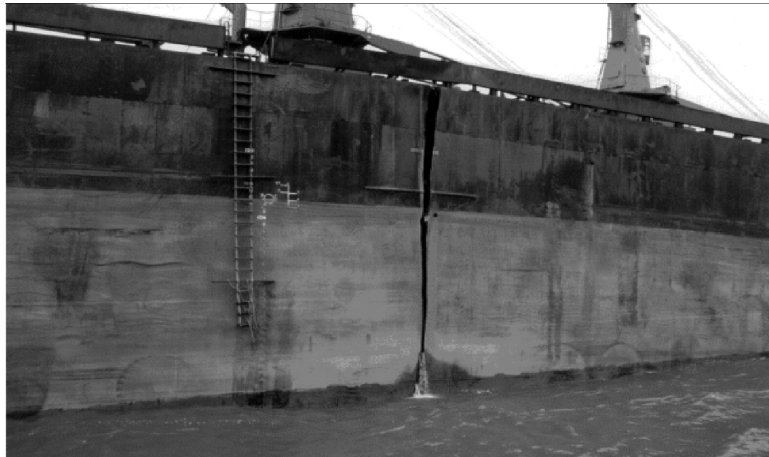
Photo 2. Starboard side fracture

At approximately 0015 on 11 November 1999, a loud reverberation was heard throughout the ship. A large fracture had developed transversely across the main deck, near frame 110 on the starboard side, through the No. 4 hatch coaming, and across to frame 87 on the port side. The fracture extended down both sides and stopped just short of the hopper tanks. Holds 3 and 4 were opened to the sea and the fracture on the main deck was as wide as 0.52 m in some places (see Photographs 2, 3, and 4).

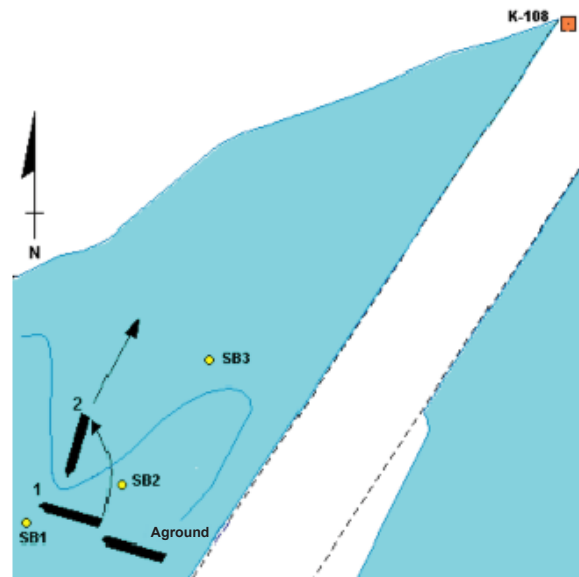
Figure 6. Refloating manoeuvre (“SB” are special buoys used for the refloating; positions approximate)

At approximately 1540, under her own power and with the help of the tugs fore and aft, the *Alcor* was first moved forward (see Figure 6, position 1) and then pivoted, the stern moving to starboard, until the vessel was on an approximate heading of 215° T, parallel with the shoals on either side (see Figure 6, position 2). Once in this orientation, sternway was put on using the stern tug and the engine of the *Alcor*. The operation was executed as initially planned.

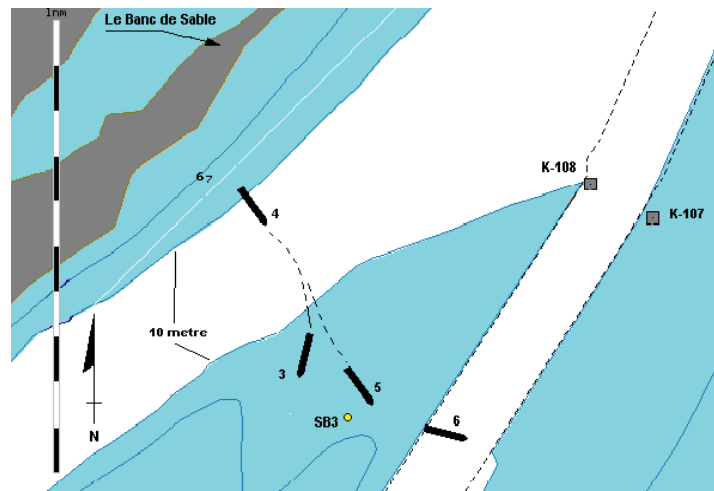
Figure 7. Refloating into channel (positions are approximate)

At approximately 1550, with the bow of the *Alcor* just past the special buoy to port (see Figure 7, position 3), the salvage master asked if one of the pilots was ready to assume conduct of the vessel. The first pilot replied in the affirmative and took the con, asking the stern tug to pull in the direction of the K-108. The second pilot was using one of the radars and the salvage captain the other. Although visibility had been good before the refloating, it had now diminished to approximately 0.5 nm, and even less at times.

The *Alcor* was still going astern when the salvage captain, who was also plotting positions on the chart, declared that the vessel was coming dangerously close to the shoal named “Le Banc de Sable”, 1.2 nm south-southwest of Cap Tourmente. Although the second pilot, who was verifying the vessel’s position on the radar, was sure the vessel still had plenty of sea room, the first pilot, who had the con, ordered the stern tug to stop pulling and ordered ahead engine on the *Alcor*. The salvage master put the engine-room telegraph to half ahead (see Figure 7, position 4).

During the astern manoeuvre, the *Alcor* had inadvertently been allowed to turn to port, from an initial heading of 215° T to somewhere between 140° T and 150° T. There are differing views as to why this happened, but it is generally accepted that there was an unwanted pulling in the forward tug's towline as the astern manoeuvre was carried out. Ideally, this line would have remained slack throughout the astern manoeuvre. Later, with ahead thrust from the *Alcor* and the forward tug now pulling, the *Alcor* stopped moving astern and began to move forward. Shortly thereafter, at approximately 1615, out of the mist ahead and to starboard, the buoy SB3 became visible from the wheelhouse of the *Alcor* (see Figure 7, position 5). The second pilot, who had been assisting, became more assertive in the absence of any orders from the first pilot. He ordered the lead tug to pull the *Alcor* in the direction of K-108, in order to distance the vessel from the shoal water to starboard. This action further moved the bow of the *Alcor* to port, to a heading of between 110° T and 100° T as the vessel entered the channel (see Figure 7, position 6).

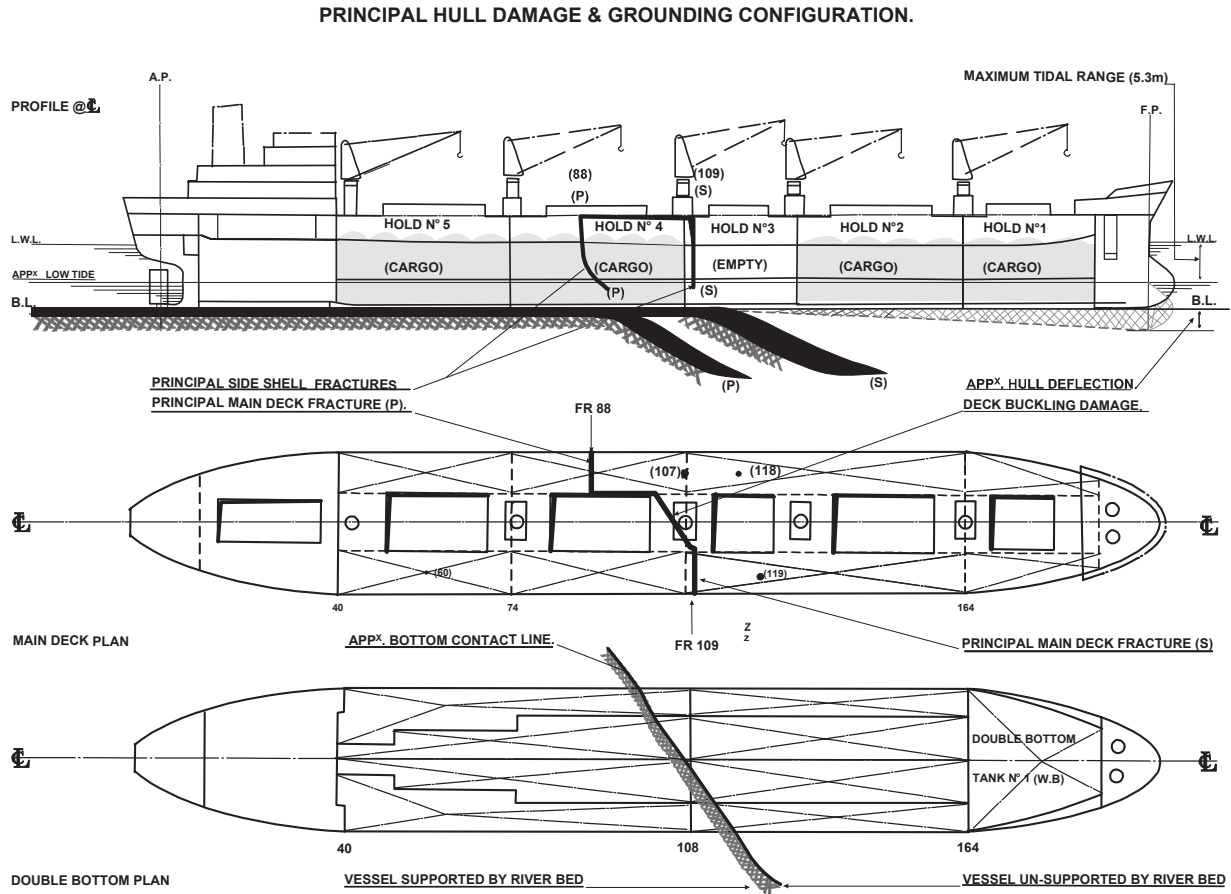
Figure 8. Principal hull damage

Principal fractures in the port and starboard side shell plating breached the watertight integrity of cargo holds 3 and 4 and upper wing water ballast tanks 2 (S) and 3 (P). The width of the fractures across the main deck plating near midships widened to approximately 0.52 m.

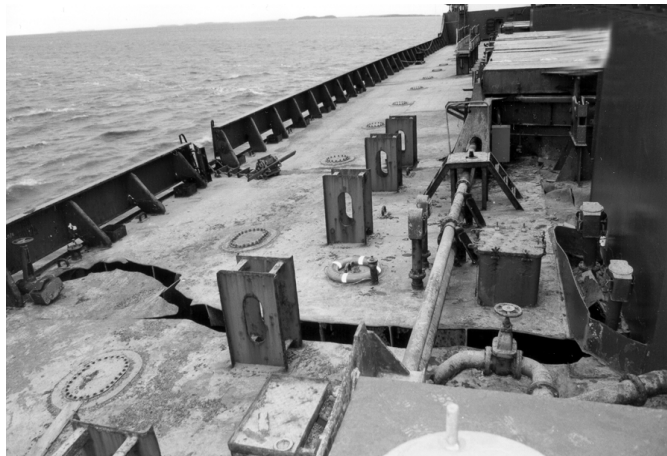
Photo 5. Main deck fracture

Tensile stress concentrations at minor discontinuities in the upper members of the hull girder initiated brittle fractures in the main deck plating that subsequently propagated across the deck, into the deck longitudinal, then through the sheer strake and gunwale, finally propagating down the side shell plating.

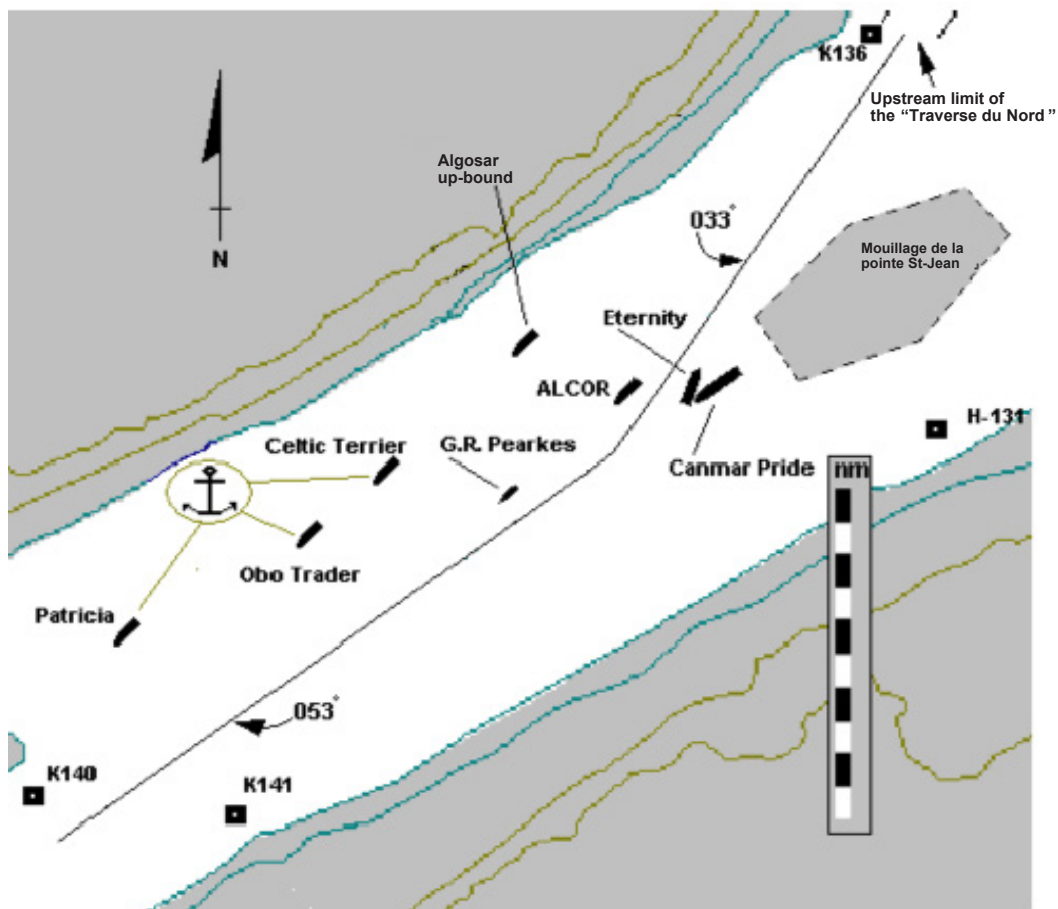
Figure 10. Vessel positions as *Eternity* and *Canmar Pride* pass

~2259	<p>The pilot on the <i>Canmar Pride</i> again calls the <i>Eternity</i> to voice his concern about what he considers to be a developing close-quarters situation.</p> <p>The <i>Eternity</i> is by now committed to the port turn with the wind and current on her port side.</p> <p>The pilot on the <i>Eternity</i>, after another brief VHF conversation with the <i>Canmar Pride</i>, now makes emergency avoidance manoeuvres: puts engines full ahead and orders 20° starboard helm to kick the stern free of the <i>Canmar Pride</i>.</p> <p>The <i>Canmar Pride</i> also executes emergency manoeuvres: ceases weighing anchor (leaving about three shackles in the water), and full-astern engine is initiated.</p>
~2301	<p>The starboard quarter of the <i>Eternity</i> comes within 30 m of the starboard bow of the <i>Canmar Pride</i>, now going astern (see Figure 10).</p>

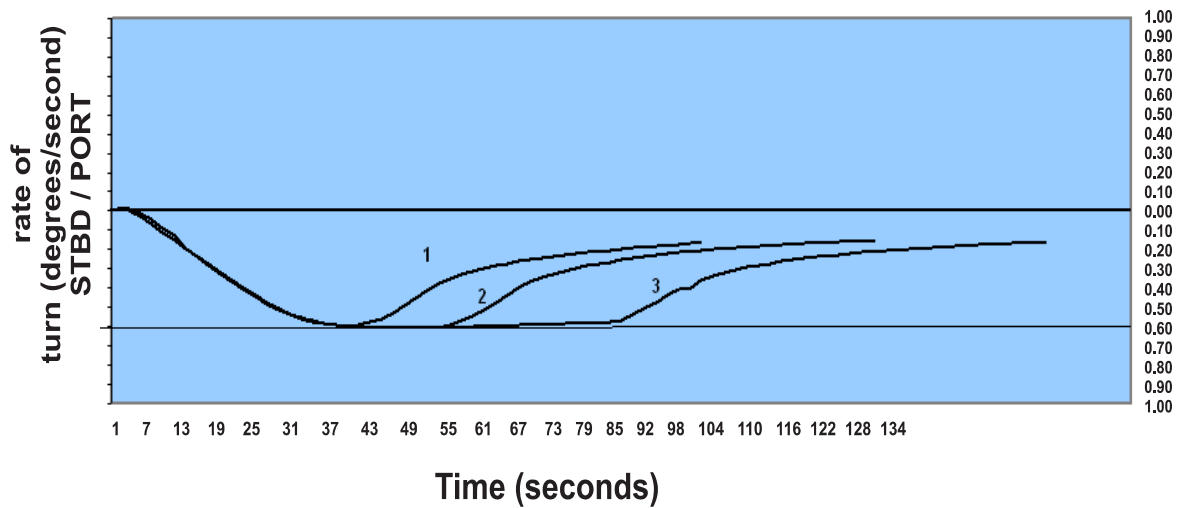
Simulation 1- helm gradually brought to starboard, then hard to starboard for 12 seconds, then to midships
 Simulation 2- helm gradually brought to starboard, then hard to starboard for 28 seconds, then to midships
 Simulation 3- helm gradually brought to starboard, then hard to starboard for 56 seconds, then to midships
